Monitoring Completed Navigation Projects (MCNP) Program

18-19 October 2004 (FY05) Fort Belvoir, Virginia

MONITORING COMPLETED NAVIGATION PROJECTS

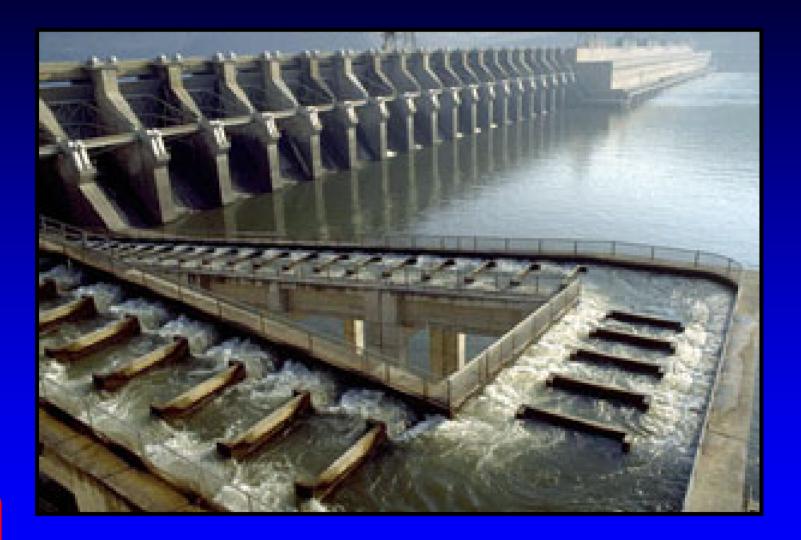
Fish Passage Ladder, John Day Lock and Dam

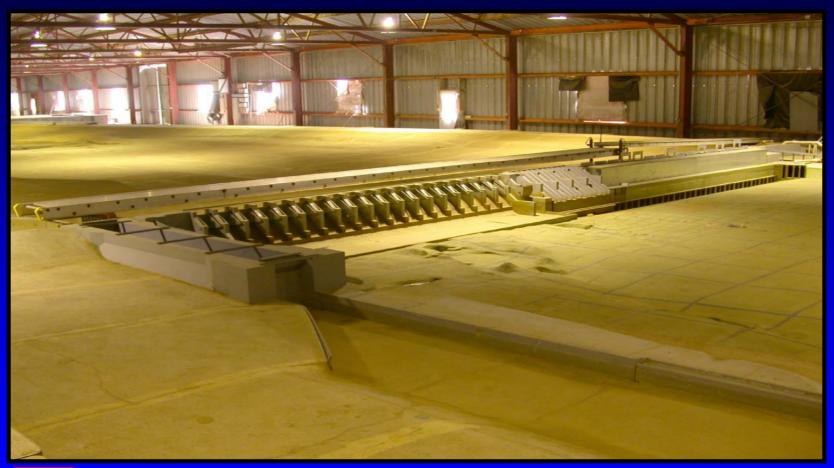
Existing ERDC Physical Model, John Day Lock and Dam

The existing physical model predicts a significant volume of flow moving from the spillway toward the powerhouse, opposite in direction from what was measured by a limited 2003 Acoustic Doppler Current Profiler (ADCP) survey. This reverse entrainment in the model is believed to be directly related to underestimating the current velocities in the vicinity of the navigation lock approach.

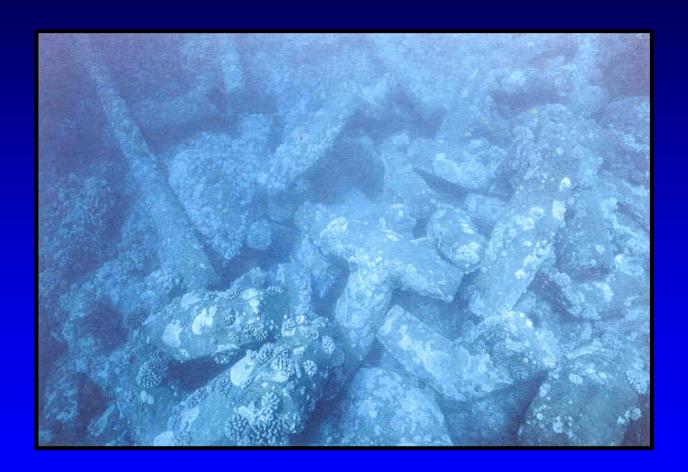
Existing Underwater Section Kaumalapau Harbor Breakwater

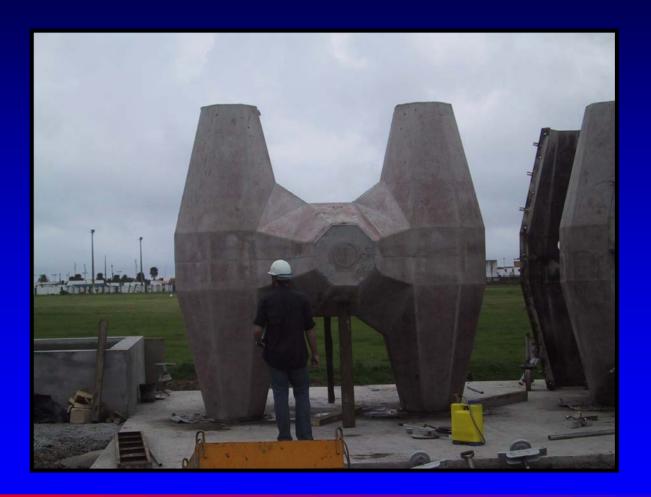
35-Ton Core-Loc for Rehabilitating Kaumalapau Harbor Breakwater

Because of the non-availability of large quarry stone, it is necessary to use manufactured armor units at this site (water depths 70 ft; wave heights 30 ft). 35-ton Core-Loc armor units (largest ever manufactured) will be installed (790 units). Will be placed over existing broken dolos armor units. It is significantly important to understand the design, stability, construction, and performance of these units.

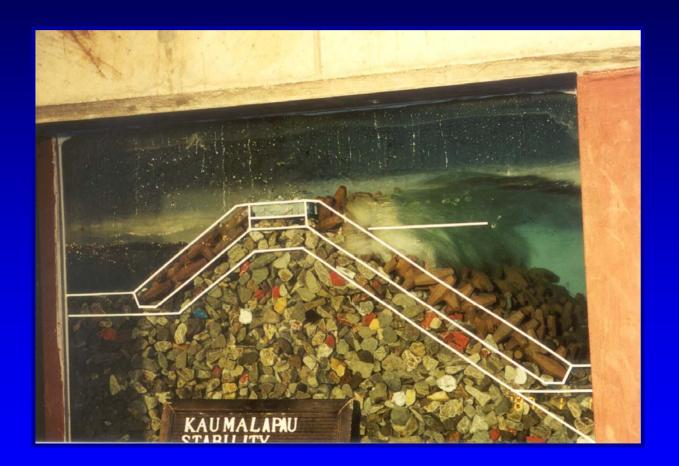
ERDC Physical Model Stability Tests Kaumalapau Harbor Breakwater

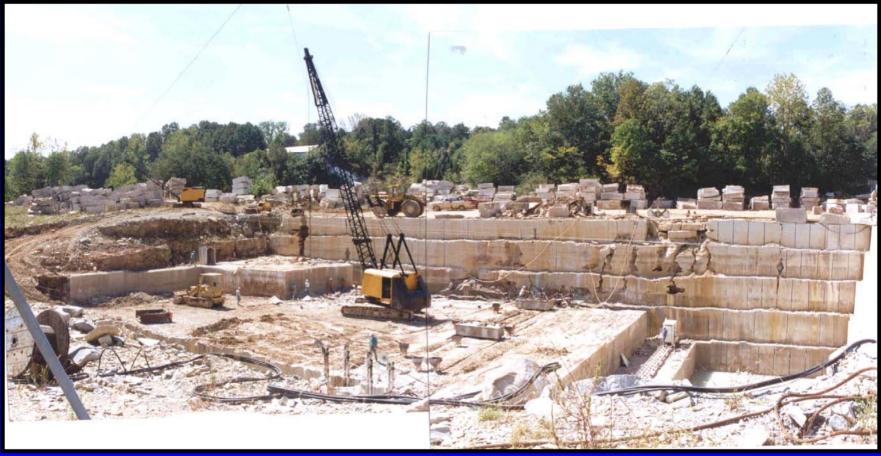
Wire-Saw Cut Quarry Operation Reed Quarry, Bloomington, IN

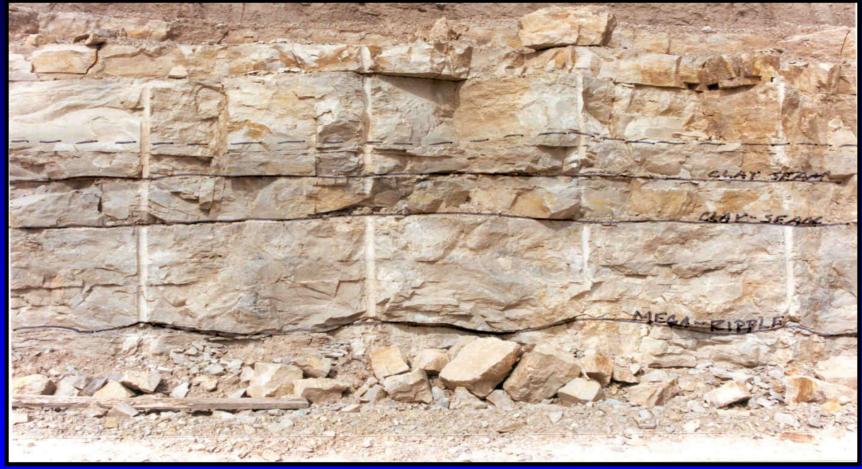
Drilled and Blasted Quarry Operation Valders Quarry, Valders, WI

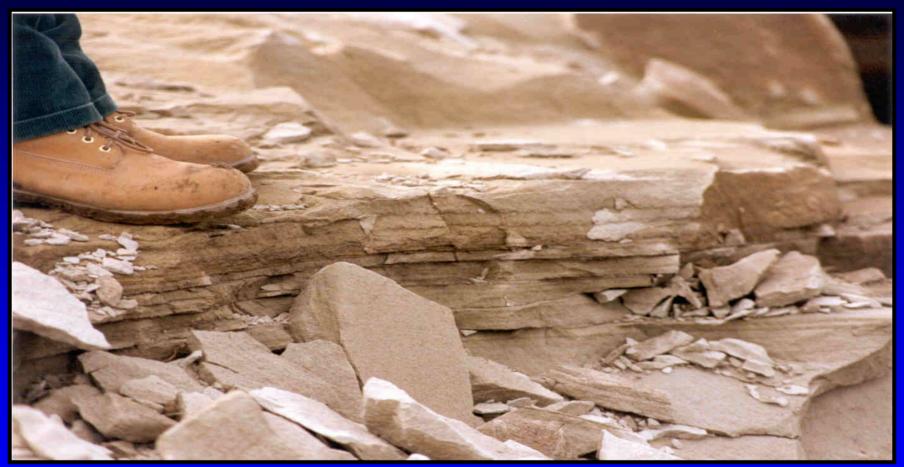
Thin-Bedded Carbonaceous Sandstone Johnson Quarry, Kipton, OH

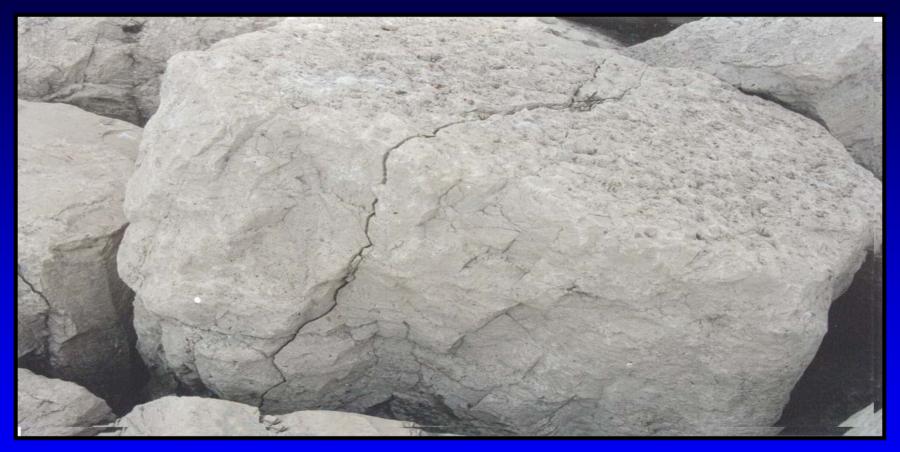
High-Energy Blasted Dolomite McCook Quarry, McCook, IL

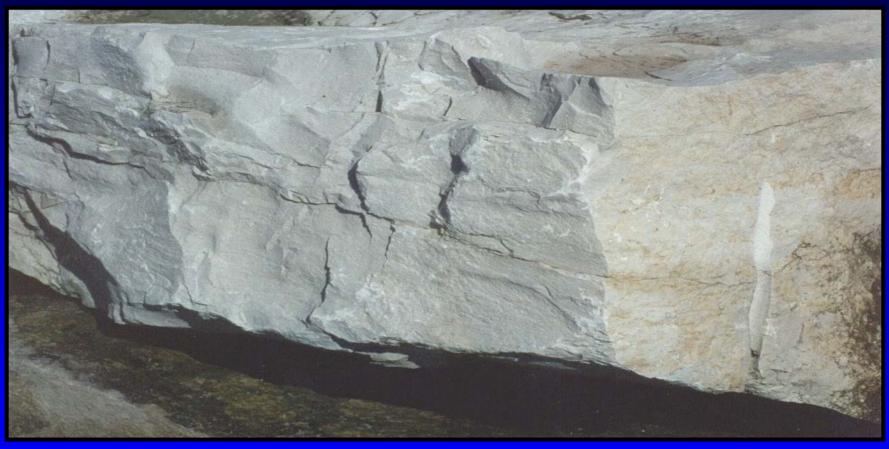
Low-Energy Blasted Dolomite Valders Quarry, Valders, WI

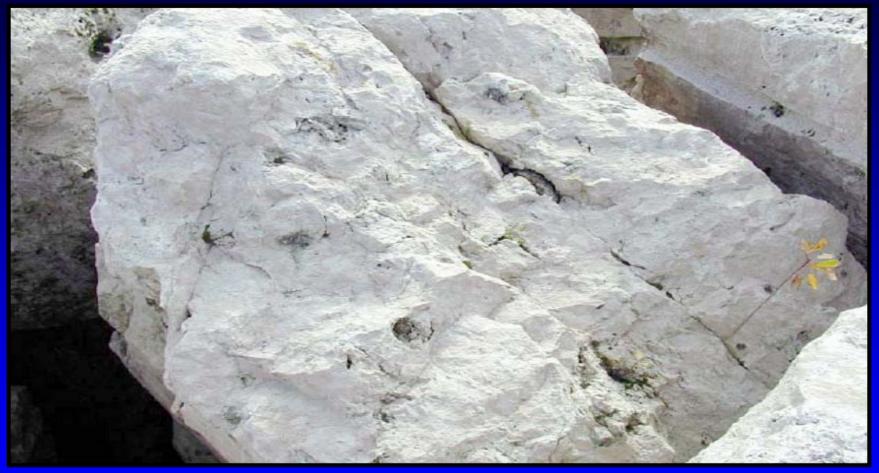
Separations at Dolomite Planar Weaknesses Even with QA/QC

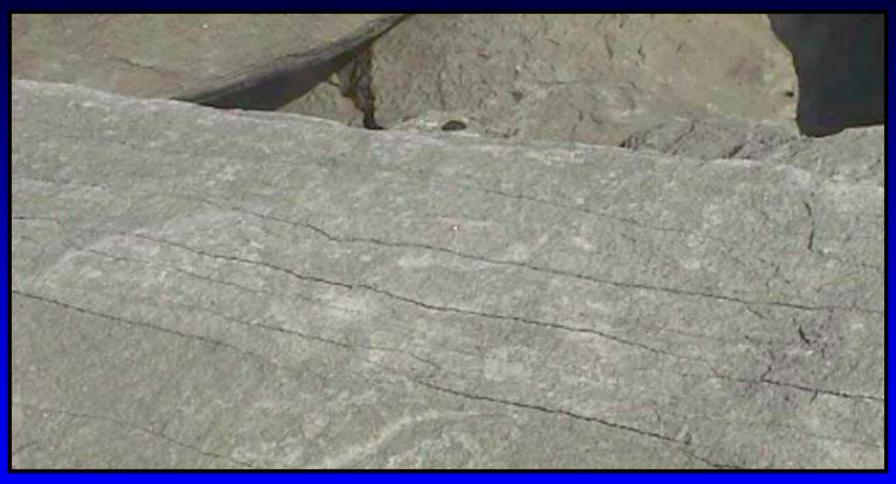
Bedding Planes in Limestone Blocks along Chicago Shoreline

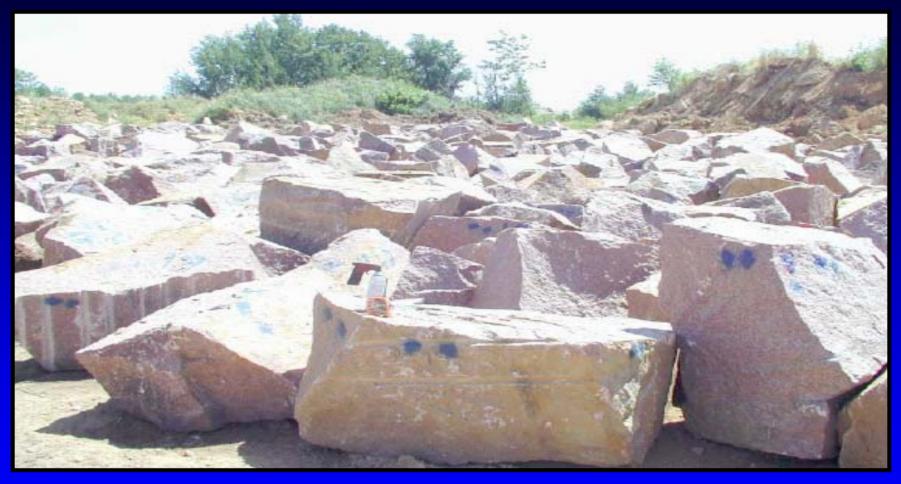
Blasted Granite Armorstone - Note Absence of Discontinuities

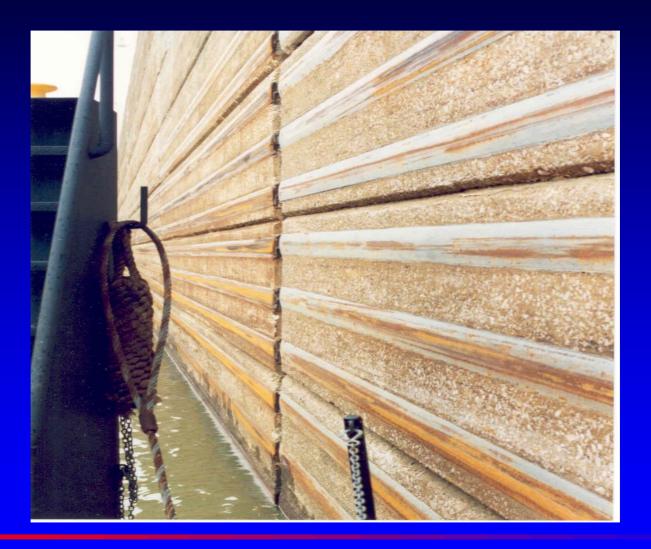
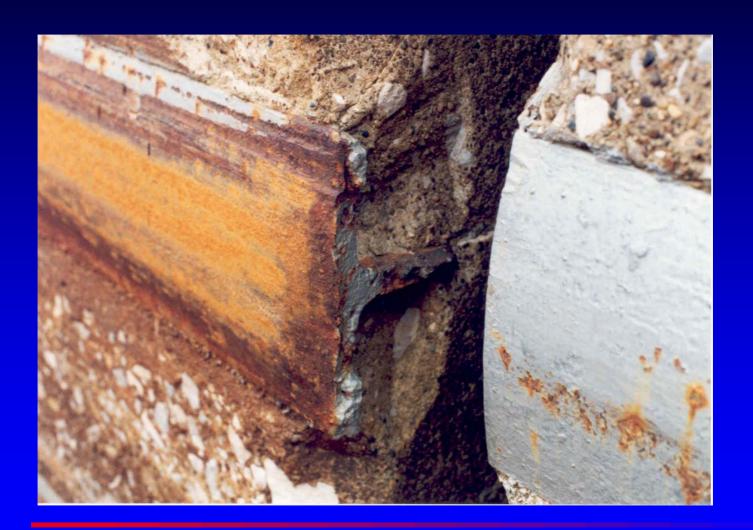
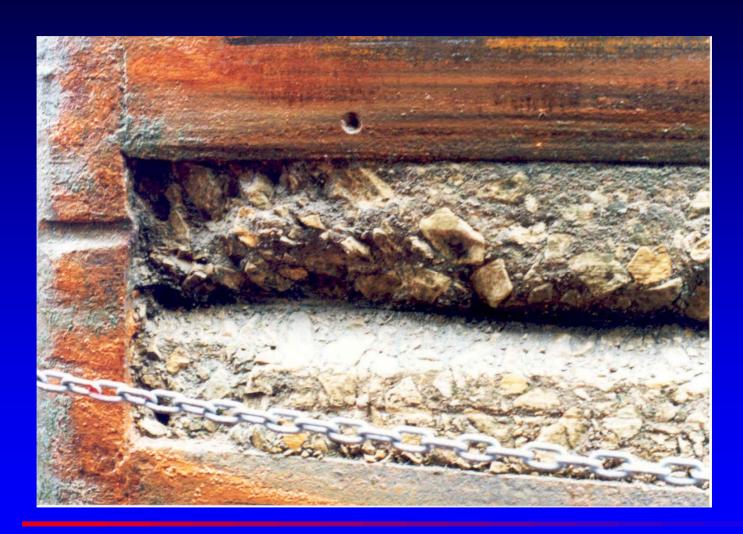
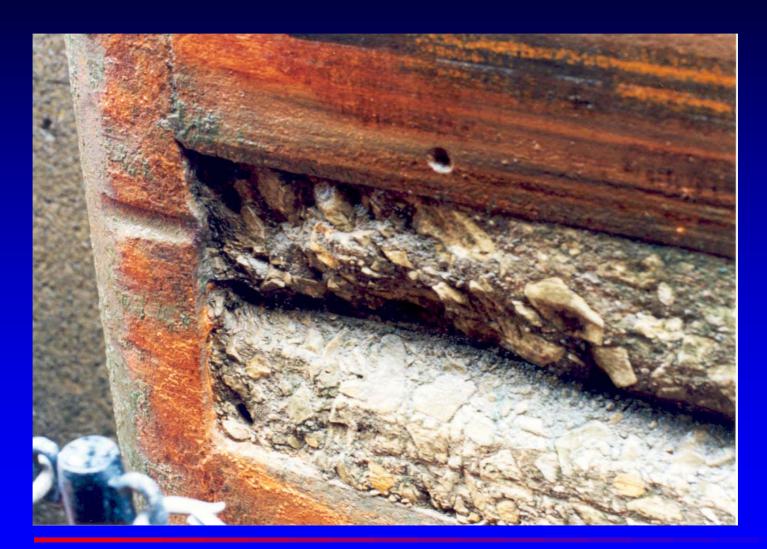
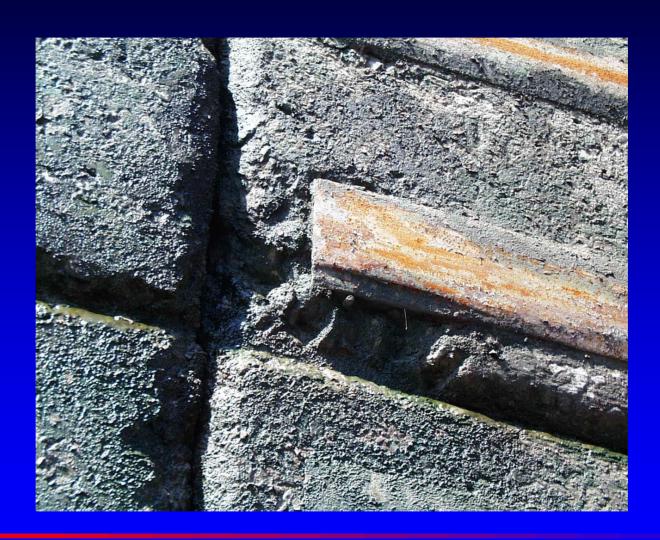
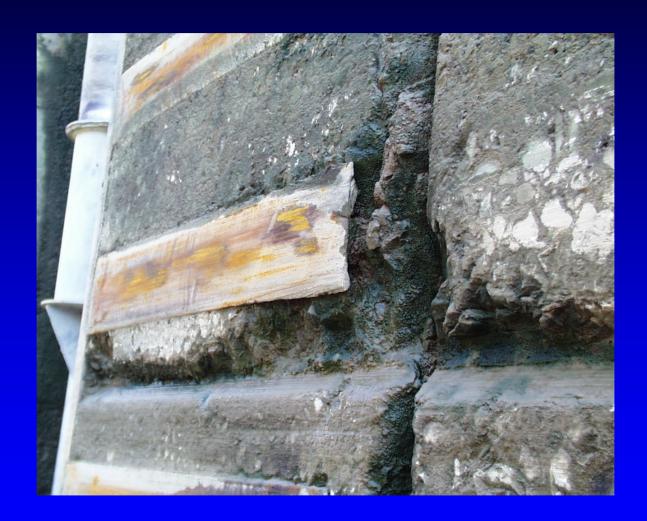
Lock Wall Armor System

Lock wall armor system is experiencing a large amount of damage due to the large number of vessels passing through the locks. Majority of damage includes gouges and spalls in the concrete adjacent to armor strips. Many of the gouges are next to vertical joints. Several locations includes broken armor.

Majority of damage occurs in 1,200-ft lock, due to impact and abrasion by commercial barge traffic that typically use this lock. Broken wall armor is vulnerable to "catching" protruding metal on barges (a special concern for barges that have protection themselves). When armor is worn flat, it is no longer effecting in protecting the surrounding concrete.

The design parameters for this lock were insufficient, resulting in extensive wear of the lock walls. Design did not provide for wall armor protection at the concrete joints, with considerable damage to the concrete and armor. Performance prediction technology was not fully utilized.

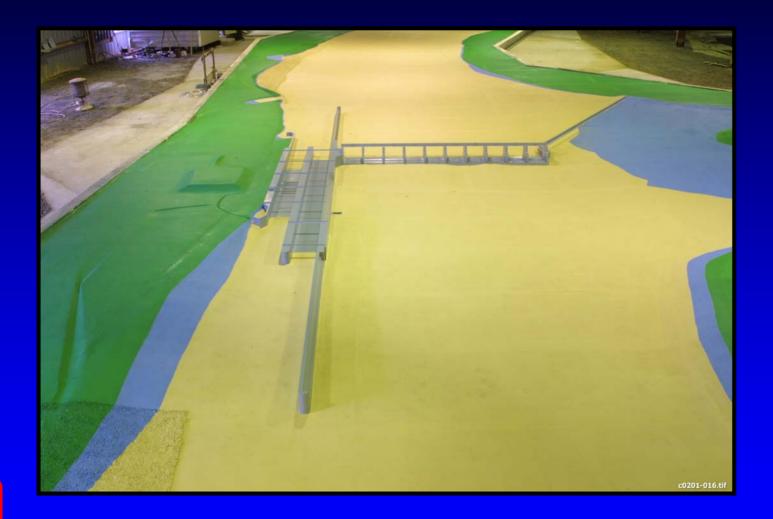
Existing ERDC Physical Model, John T. Myers Locks and Dam
